Manhole Inspection Summary

Manhole # S45K__026MH

Insp Date: **4/29/08 1:36 PM**

Location Address: **628 s wolfe st**

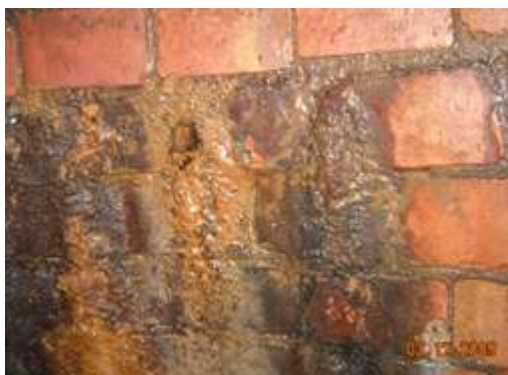
Defect 3

INFILTRATION @ BARREL MORTAR

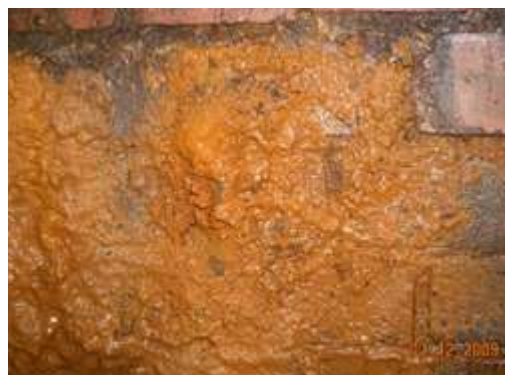
Defect 2

infiltration from barrel wall

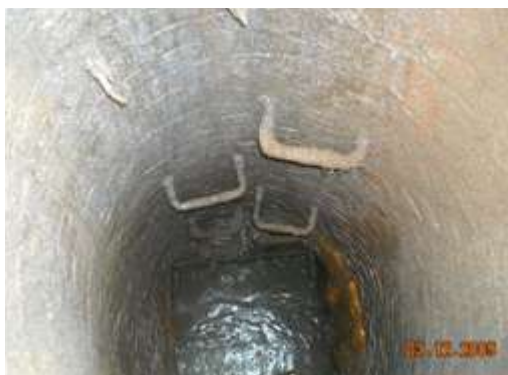
Defect 1

Missing: **3**

☒ **Corroded**

CORRODED AND MISSING STEPS

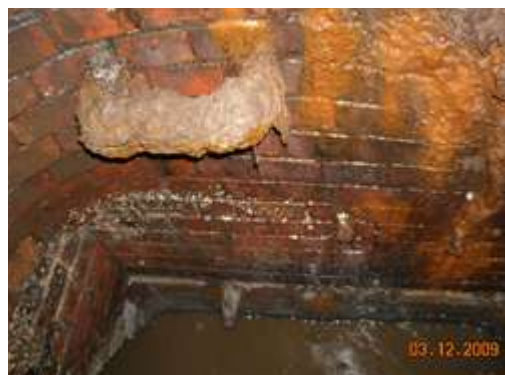
Defect 6

☒ **Evidence Of Surcharge**

Depth: **4**

SURCHARGE EVIDENCE

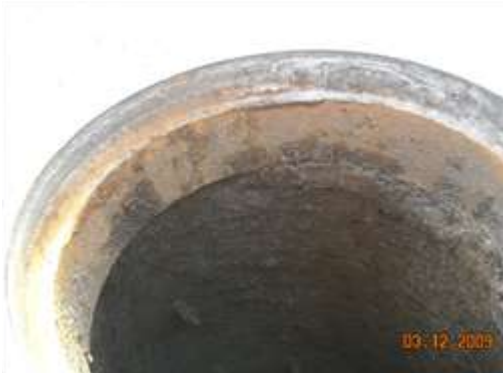
Defect 5

INFLOW EVIDENCE FROM SHEETING;
CORBEL JOINT INFILTRATION

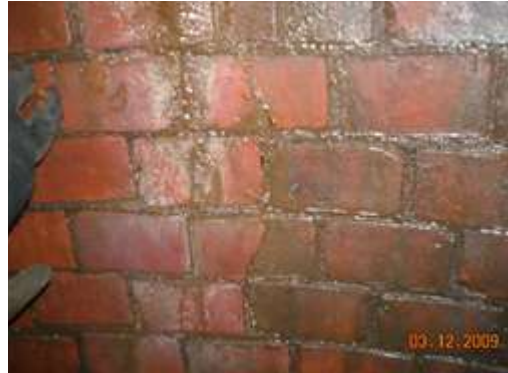
Defect 4

barrel cracked with infiltration from cracks
